SS209H

KUBOTA RTV'S

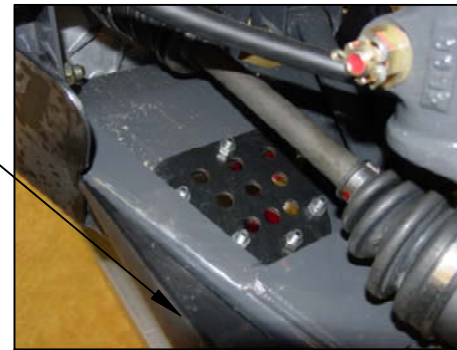
REMOVE THE PLASTIC GUARDS.

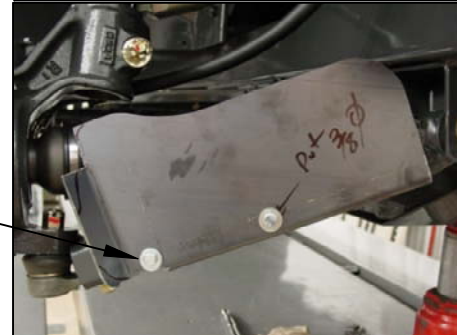
THIS IS A PIC. OF THE FRONT OF THE GUARD USE THE 1/4 BOLTS WITH THE 1/4 WASHERS AND LOCK NUTS.

DO NOT MOUNT THE GUARDS ON BACKWARDS. THE BENT SIDES OF THE GUARDS WILL FACE FORWARD. EXAMPLE ON 2ND PIC.

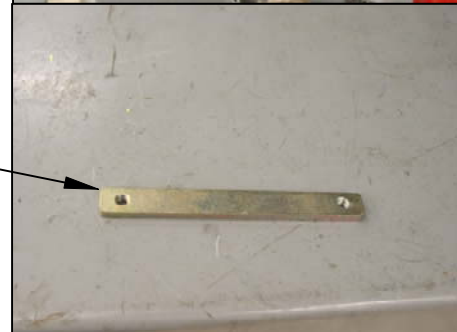
THIS IS A PIC. OF THE THREADED FACTORY PLATE THAT WILL BE REMOVED. SOME OF THE NEWER MACHINES MAY NOT HAVE THIS BRACKET.

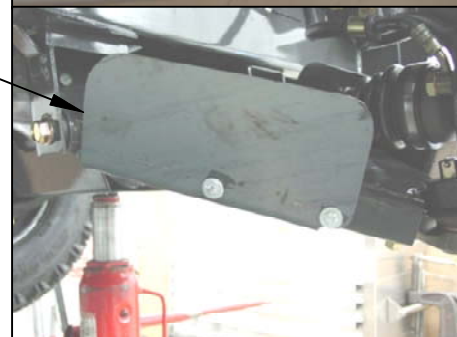
THIS IS A PIC. OF THE REAR OF THE SS209H STICK STOPPER USE THE TWO 1/4 X 1 BOLTS AND 1/4 LOCK NUTS TO BOLT THE REAR OF THE STICK STOPPER TO THE A-ARM.

WHEN INSTALLING GUARDS LEAVE ALL FASTENERS LOOSE UNTIL ALL HARDWARE IS IN PLACE THEN PROCEED TO SECURE THE GUARDS. MUST CHECK FOR PROPER CLEARANCE FOR THE RIMS AND BRAKE CALIPERS. TO CHECK FOR THIS LIFT THE FRONT OF THE ATV OFF THE GROUND AND TURN WHEELS FROM LEFT TO RIGHT AND MAKE SURE NOTHING IS TOUCHING THE GUARDS.
